BS 6375-1:2016

Profile Developments Single open in doorset

Performance of windows & doors
Part 1: Classification for weathertightness

Profile Developments

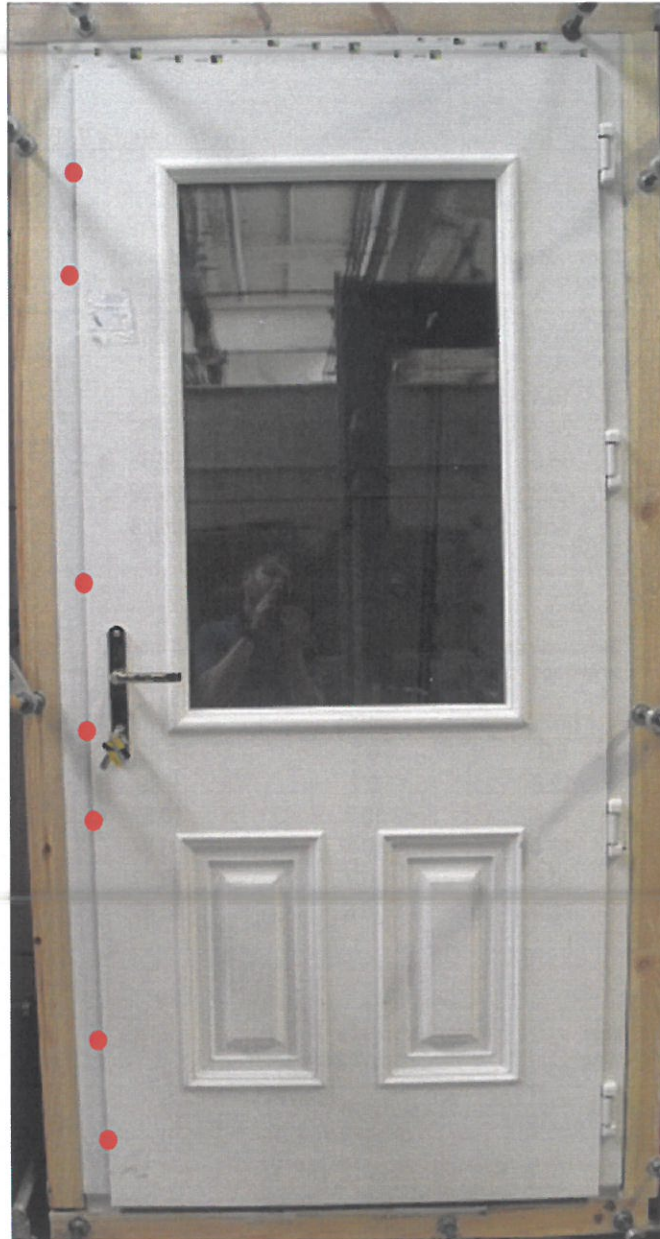
Door Assembly

Sample Details:	Profile Developments Palladio door set
Fabricator:	Profile Developments & Liniar
Material:	UPVC FRAME & GRP DOOR LEAF. OUTER FRAME CORNERS WELDED, THRESHOLD MECHANICAL FIXED Outer frame : LSW016 Reinforcement : Steel LSR106 Leaf : 68mm Composite slab
Finish:	White
Lock:	Lock : Yale Mantis Keeps : Yale OPK
Hinges:	Palladio composite door hinge with dog bolt
Cylinder:	YALE 1* Superior cylinder
Handle:	Mila Pro Secure lever/Lever
Fixings:	Lock : 4.3 x 30 CSK Keep : 4.3 x 30 CSK Hinge to frame: 4.8 x 38 CSK drill point Hinge to leaf : 5.0 x 40 wood screw Handle : Supplied with handle set Glazing/Panel fixings : Glued
Letterplate:	N/A
Weather sealing:	Threshold : Stormguard
Glass:	Total thickness : Triple Glazing Supplier : Profile Developments
Glazing system:	Glued internal and external beads
Sample dimensions:	Frame : 1000 X 2100 Each Leaf : 850 X 1970

Locking point ●
