PAS 24:2016

Profile Developments open in door sets

Enhanced security performance requirements
for doorsets and windows in the UK

Profile Developments

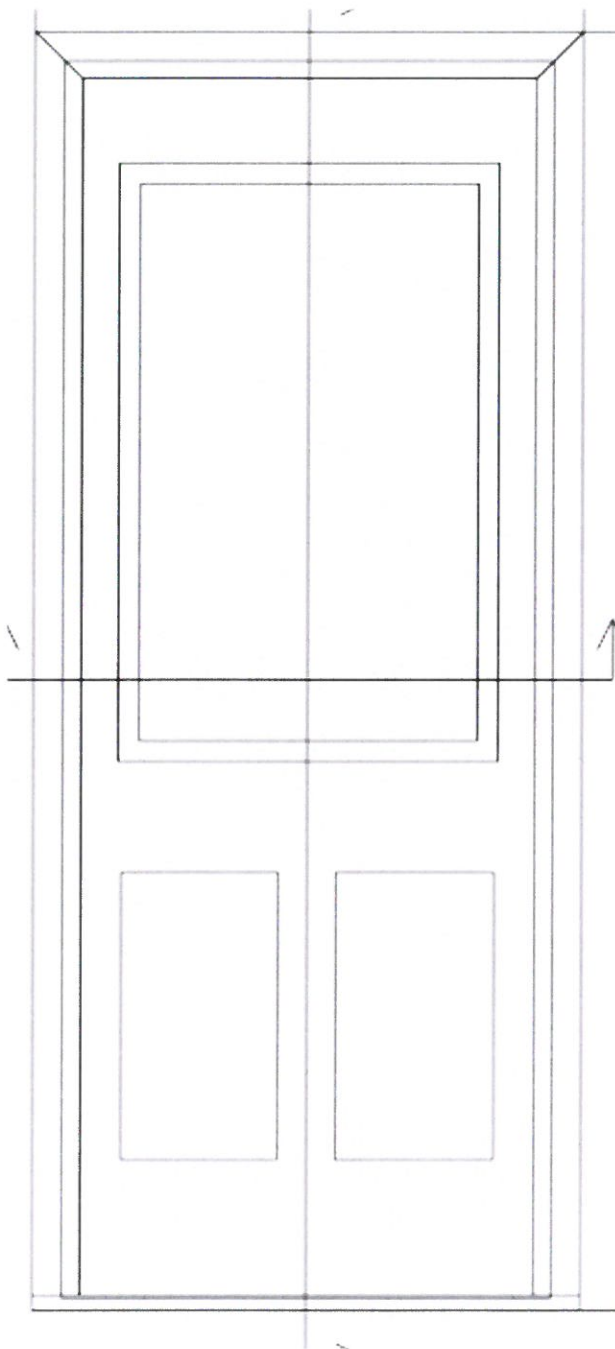
Figure 1 – General Elevation

Sample Details:	Profile Developments Palladio door set
Fabricator:	Profile Developments & Liniar
Material:	UPVC FRAME & GRP DOOR LEAF. OUTER FRAME CORNERS WELDED, THRESHOLD MECHANICAL FIXED Outer frame : LSW016 Reinforcement : Steel LSR106 Leaf : 68mm Composite slab
Finish:	White
Lock:	Lock : Yale Mantis Keeps : Yale OPK
Hinges:	Palladio composite door hinge with dog bolt
Cylinder:	YALE 1* Superior cylinder
Handle:	Mila Pro Secure lever/Lever
Fixings:	Lock : 4.3 x 30 CSK Keep : 4.3 x 30 CSK Hinge to frame: 4.8 x 38 CSK drill point Hinge to leaf : 5.0 x 40 wood screw Handle : Supplied with handle set Glazing/Panel fixings : Glued
Letterplate:	N/A
Weather sealing:	Threshold : Stormguard
Glass:	Total thickness : Triple Glazing Supplier : Profile Developments
Glazing system:	Glued internal and external beads
Sample dimensions:	Frame : 1000 X 2100 Each Leaf : 850 X 1970

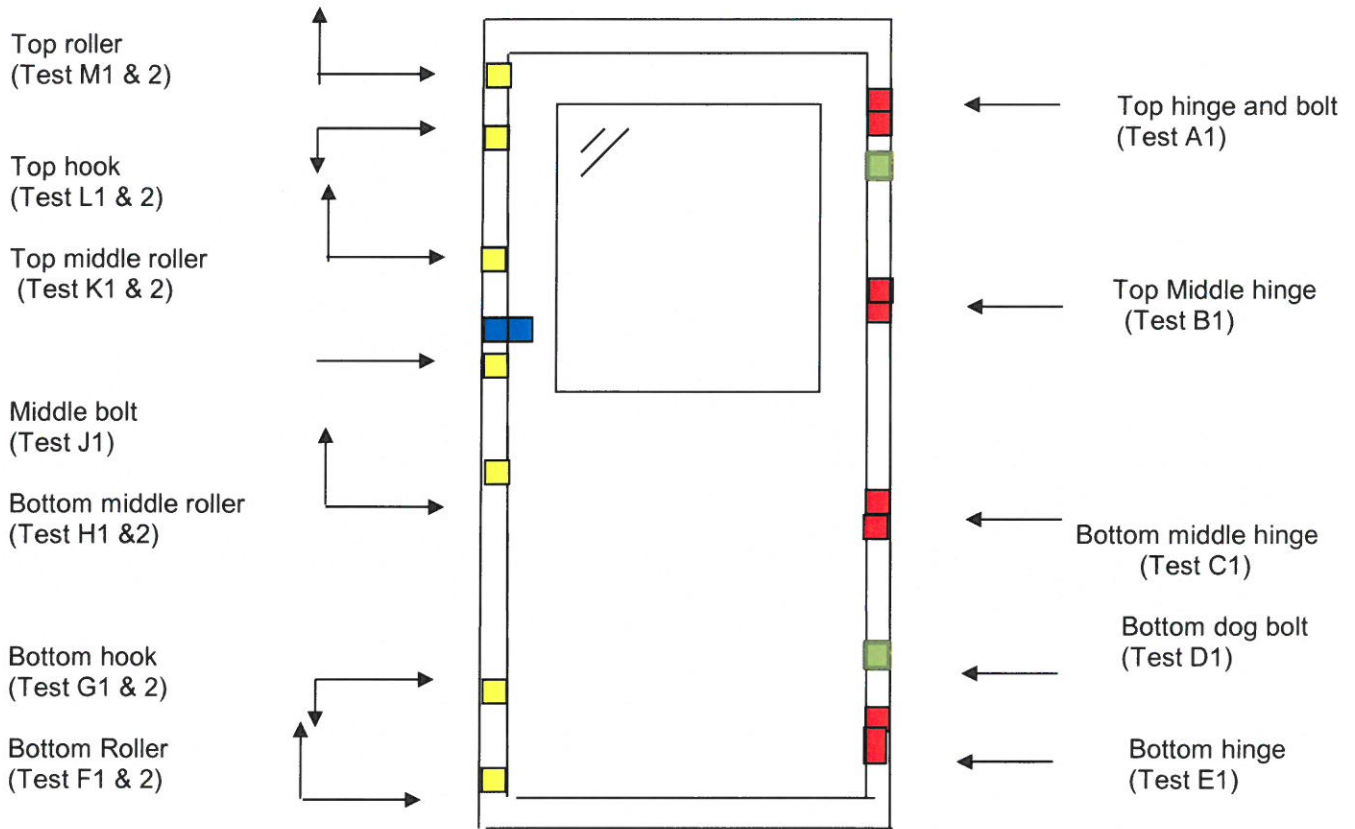
Door Layout & Loading Directions (external view)

- Hinges ■
- Dog bolts ■
- Bolts & rollers ■
- Handle ■

Test Ref.	Load Position	Requirement	Actual	Pass/Fail
A1 – Top Hinge and bolt	Parallel to plane at right angles to the edge	1.5kN (153Kg)	153Kg	----
	Perpendicular to plane	4.5kN	4518N	Pass
B1 – Top Middle Hinge	Parallel to plane at right angles to the edge	1.5kN (153Kg)	153Kg	----
	Perpendicular to plane	4.5kN	4520N	Pass
C1 – Bottom middle Hinge	Parallel to plane at right angles to the edge	1.5kN (153Kg)	153Kg	----
	Perpendicular to plane	4.5kN	4515N	Pass
D1 – Bottom dog bolt	Parallel to plane at right angles to the edge	1.5kN (153Kg)	153Kg	----
	Perpendicular to plane	4.5kN	4507N	Pass
E1 – Bottom Hinge	Parallel to plane at right angles to the edge	1.5kN (153Kg)	153Kg	----
	Perpendicular to plane	4.5kN	4508N	Pass
F1 – Bottom roller	Parallel to plane along the edge	1.5kN (153Kg)	153Kg	----
	Perpendicular to plane	4.5kN	4510N	Pass
F2 – Bottom roller	Parallel to plane at right angles to the edge	1.5kN (153Kg)	153Kg	----

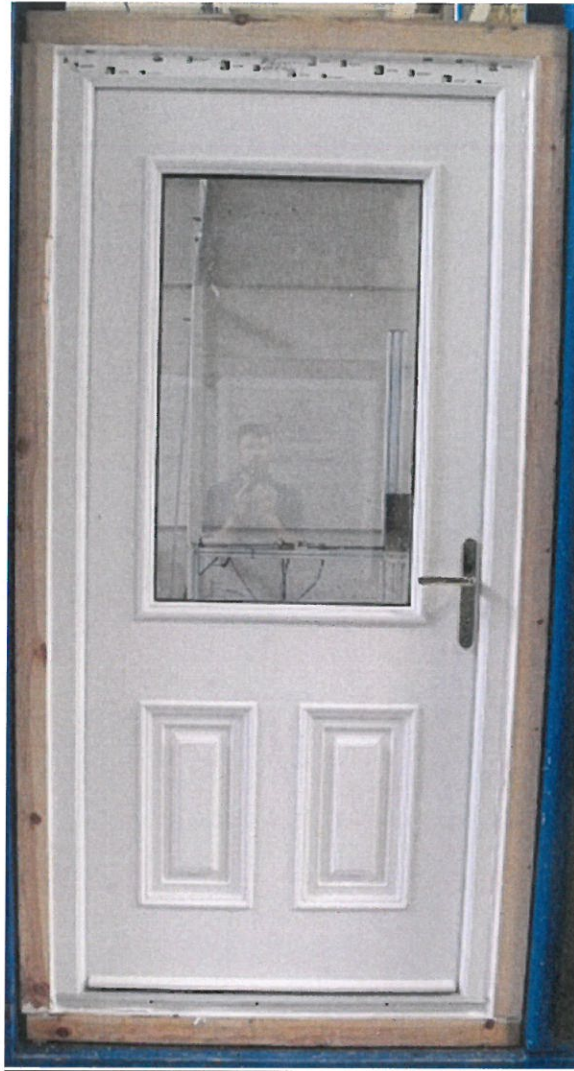
Sample received in a good working condition

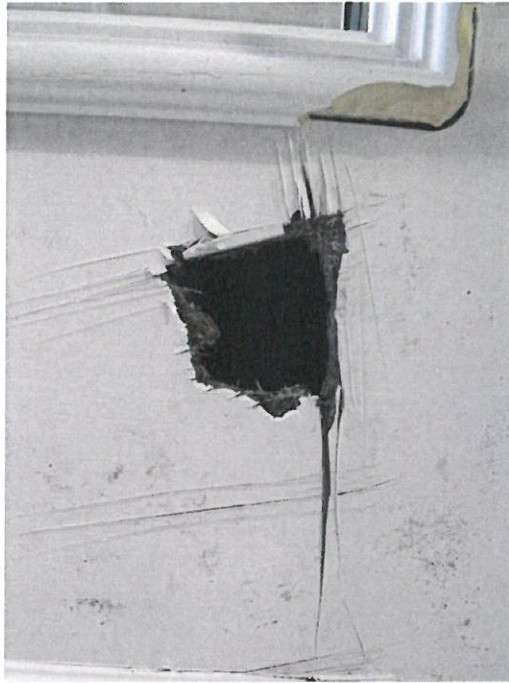
Sample following clause B.4.4.4 Zone 1

B.4.4.4 – Manual Cutting Test	<p>Zone 1 – The craft knife and the 25mm wood chisel were used independently in an attempt to create a 50mm hole through the leaf.</p> <p>Following 3 minutes a 50mm x 40mm aperture was produced in the external skin but no hole was produced through the sample.</p> <p>Zone 2 – The craft knife was used to cut the external skin. Following 3 minutes no hole was produced through the sample.</p>	Pass

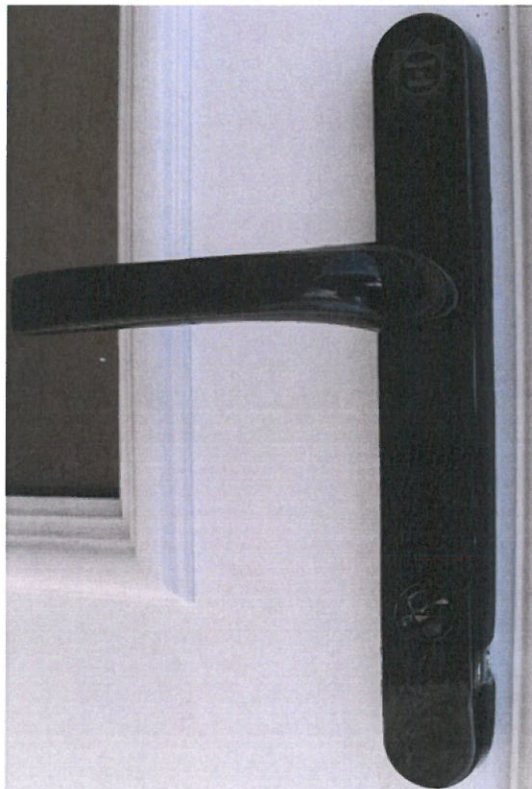
Sample following Annex A part 1 attack testing

Test	Sample / Actual	Pass/Fail
A.3 – Security Hardware & Cylinder Test A.3.2 – Part 1	The craft knife was used to cut along the sides of the handle to create access for the curved jaw grips to gain a good purchase on the back plate. The curved jaw grips once attached were used in a side to side motion in an attempt to remove the handle. Following 3 minutes the cylinder and handle remained secure.	Pass
A.3 – Security Hardware & Cylinder Test A.3.3 – Part 2	4.8mm self-cutting screw was inserted into the keyway The screw was then levered with the torque wrench until the screw lost traction and was removed from the cylinder. Total test time 1 minute 31 seconds the cylinder remained secure	Pass
